Manhole Inspection Summary

Manhole # S13II2012MH

Insp Date: **6/30/06 1:59 PM**

Location Address: **2108 NORTHCLIFF DR**

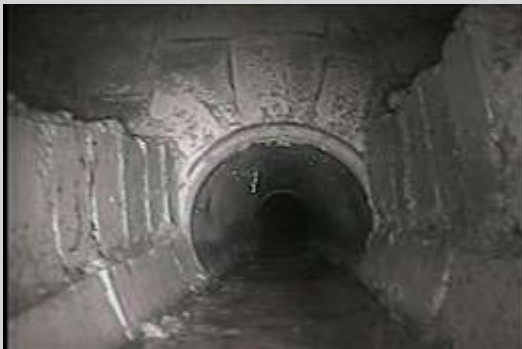
8 in. Circular Gravity Sewer Pipe In @ 6 O'Clock

Rod and Bar (Angled)

Pipe Material: **Clay** ☐ Pipe Lined

Infiltration: **None** Pipe Seal Cond: **Unknown**
